Firmware Update Required

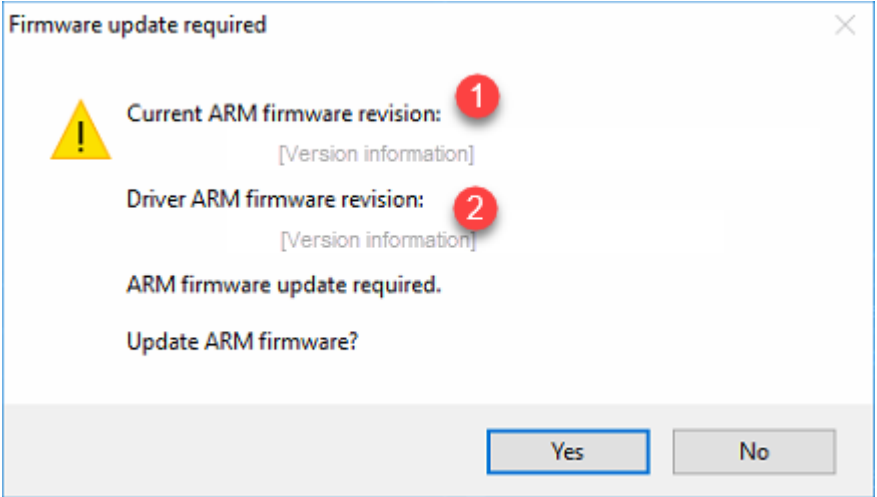
If the HP Oxygen software requires a firmware newer than your board has, then on starting the system, the message is displayed:

On figure: 1 - firmware on your board; 2 - firmware required by HPO.

Make sure the required firmware is newer than the current on your board and accept the update by clicking **Yes**. This will update the firmware of your board.

If you select **No** then the system will start without firmware update but problems with the hardware detection and functioning may occur.
