Firmware Update Required

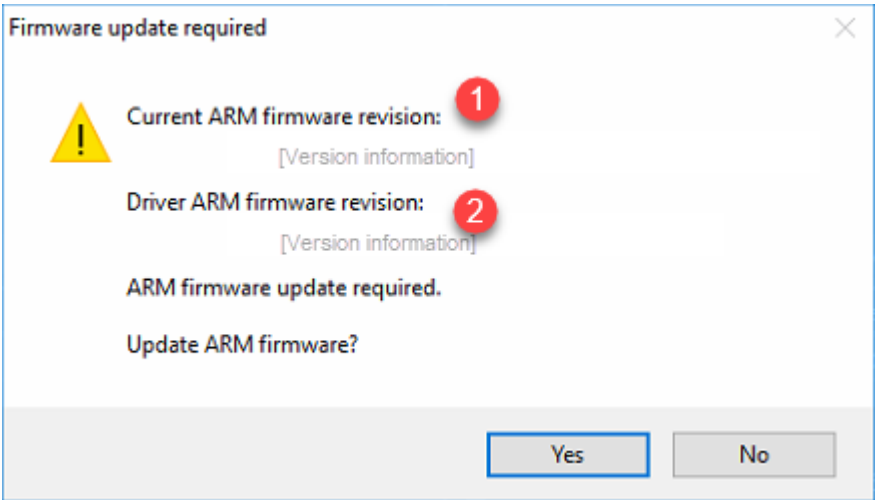
If the HP Oxygen software requires a firmware newer than your board has, then on starting the system, the message is displayed:

On figure: 1 - firmware on your board; 2 - firmware required by HPO.

Make sure the required firmware is newer than the current on your board and accept the update by clicking **Yes**. This will update the firmware of your board.

If you select **No** then the system will start without firmware update but problems with the hardware detection and functioning may occur.

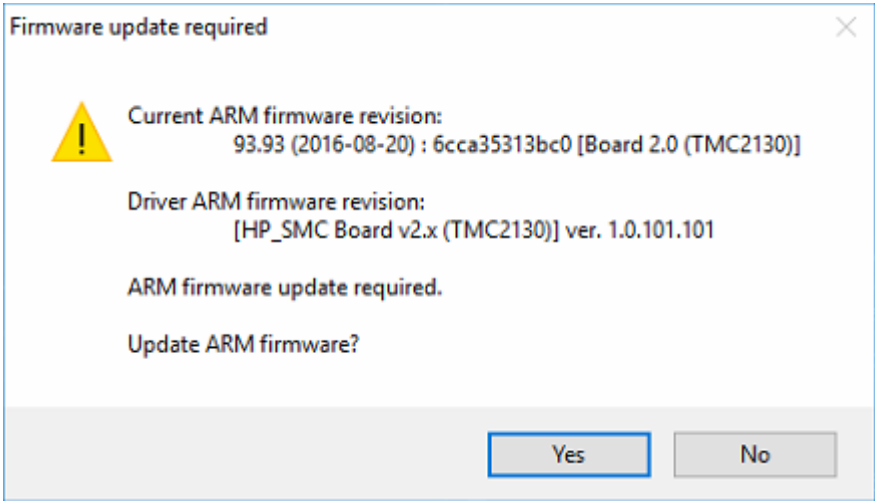
1. You use the **HP_SMC v2.0** board.
2. You start **HPOxygen Server 5.6.1** or newer. A firmware update to the newer version is suggested.

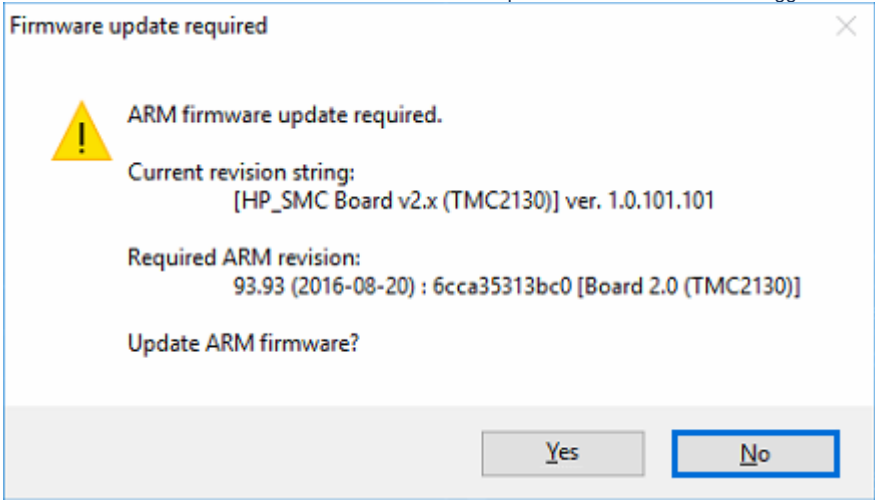
3. You perform the update.
4. You start the HPO version **older** than 5.6.1. A firmware update to an older version is suggested.

5. Accepting the update leads to motor stop working after the hardware restart.
6. Starting **HPOxygen Server 5.6.1** again **does not solve the problem**.

Versions of HPOxygen Server **older** than 5.6.1 mistakenly set version to 85.85 instead of required 93.93 which sets board to be considered HP_SMC v1.1. This prevents the motor from working and additionally when **HPOxygen Server 5.6.1** starts again, it does not try to update version as the current one held by the board is the latest for HP_SMC v1.1.

Never accept the update to an older version. In all cases click **No**.
