Firmware Update Required

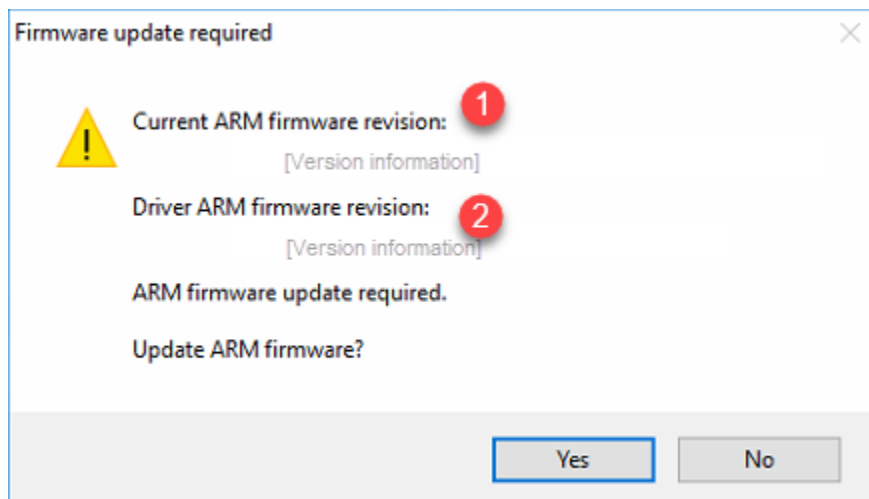
If the HP Carbon software requires a firmware newer than your board has, then on starting the system, the message is displayed:

On figure: 1 - firmware on your board; 2 - firmware required by HPO.

Make sure the required firmware is newer than the current on your board and accept the update by clicking **Yes**. This will update the firmware of your board.

If you select **No** then the system will start without firmware update but problems with the hardware detection and functioning may occur.

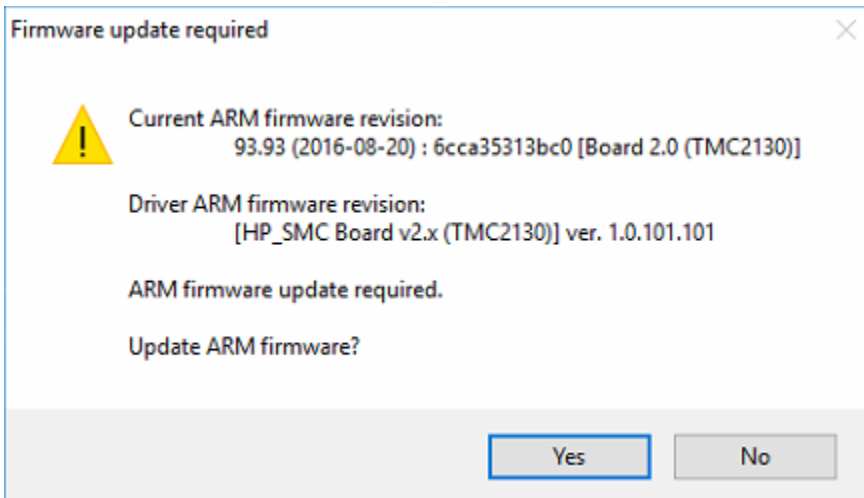
1. You use the **HP_SMC v2.0** board.
2. You start **HP Carbon**. A firmware update to the newer version is suggested.

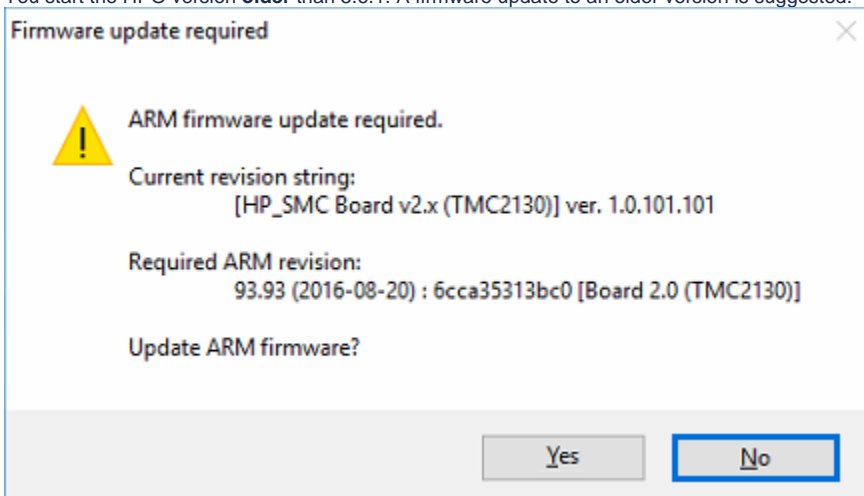
3. You perform the update.
4. You start the HPO version **older** than 5.6.1. A firmware update to an older version is suggested.

5. Accepting the update leads to motor stop working after the hardware restart.
6. Starting **HP Carbon** again **does not solve the problem**.

Some versions mistakenly set version to 85.85 instead of required 93.93 which sets board to be considered HP_SMC v1.1. This prevents the motor from working and additionally when **HP Carbon** starts again, it does not try to update version as the current one held by the board is the latest for HP_SMC v1.1.

If you accidentally accepted the update to an older version and the motor stopped working, to restore the system functioning:

1. Download and unpack the [hp_smc_tmc_firmware_update.zip](#) archive.
2. Run "update_firmware.cmd" while HP_SMC board is connected to the computer. The script will be executed in the Windows command line.
3. Start **HP Carbon**. A firmware update to the newer version will be suggested.
4. Accept the update.
